COMPENDIUM OF POST-FAILURE ANALYSIS TECHNIQUES
FOR COMPOSITE MATERIALS

RAY GROVE, BRIAN SMITH
BOEING MILITARY AIRPLANE COMPANY
P. O. BOX 3707
M/S 73-43
SEATTLE, WASHINGTON 98124

JANUARY 1987

INTERIM REPORT FOR PERIOD JULY 1984 - NOVEMBER 1986

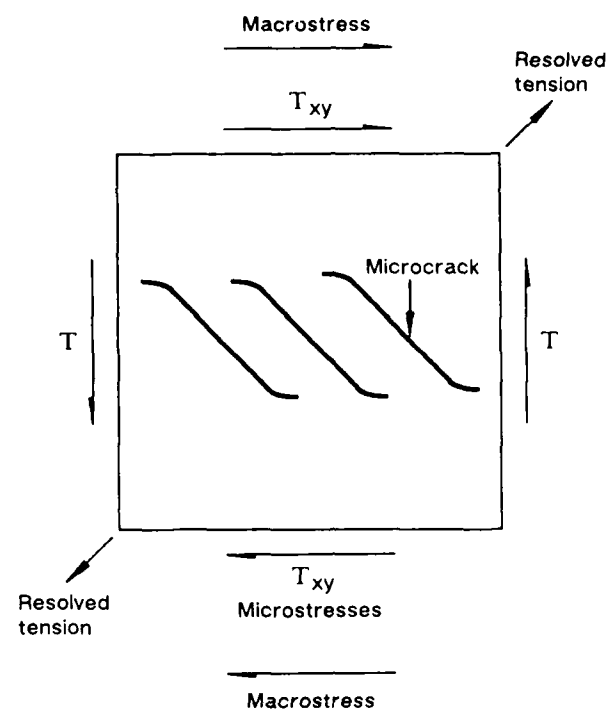
Figure 4-20. Free Body Diagram of Resolved Tensile Stresses and Inclined Microcracks

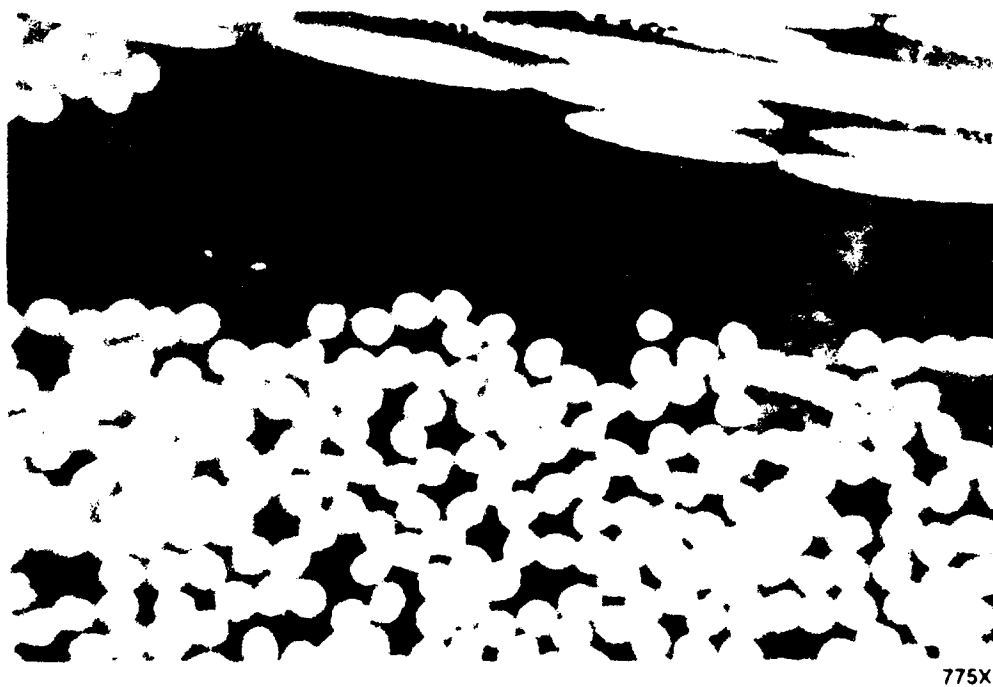
Figure 4-21. Microstructure of Cracks Found in Short Beam Shear Specimen Tested at 132°C (270°F)

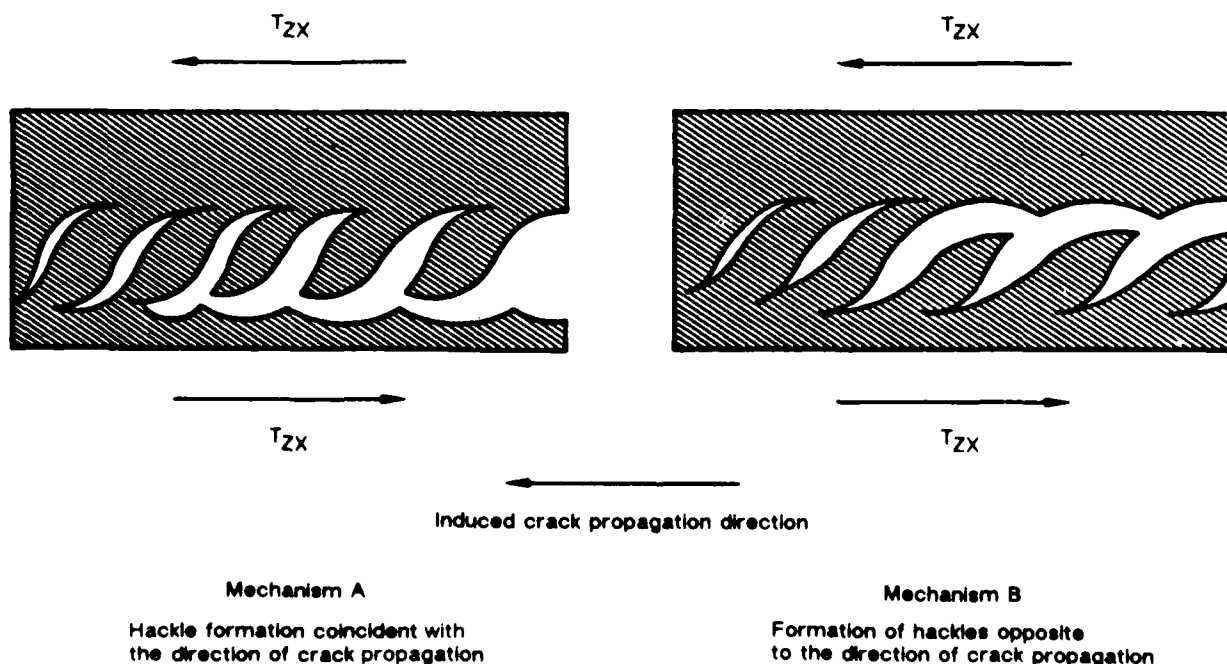
Figure 4-23. Possible Hackle Separation Mechanisms

Separation of hackles can result in two possible relationships (mechanisms A and B) between hackle tilt and the direction of crack propagation, depending on which fracture surface retains the hackle (Figure 4-23). In mechanism A, separation occurs such that the hackles are retained on the side in which the direction of crack propagation coincides with the direction of local shear component. This condition produces hackles tilted in the direction of crack propagation, and normal to the direction of resolved tension (45 degrees). Conversely, in mechanism B, separation occurs such that hackles are retained on the side in which the direction of crack propagation opposes the direction of the local shear component. In this condition, the tilt of hackles oppose the direction of crack propagation.

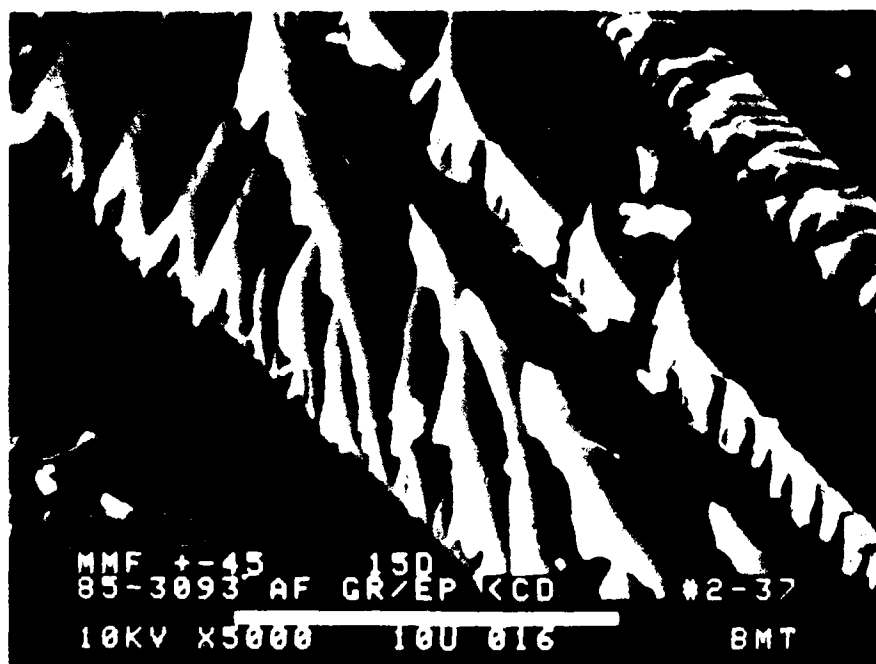
Figure 4-27. Interlaminar Mixed Mode Flexural (MMF) (Tension and Shear) Specimen Fracture Morphology

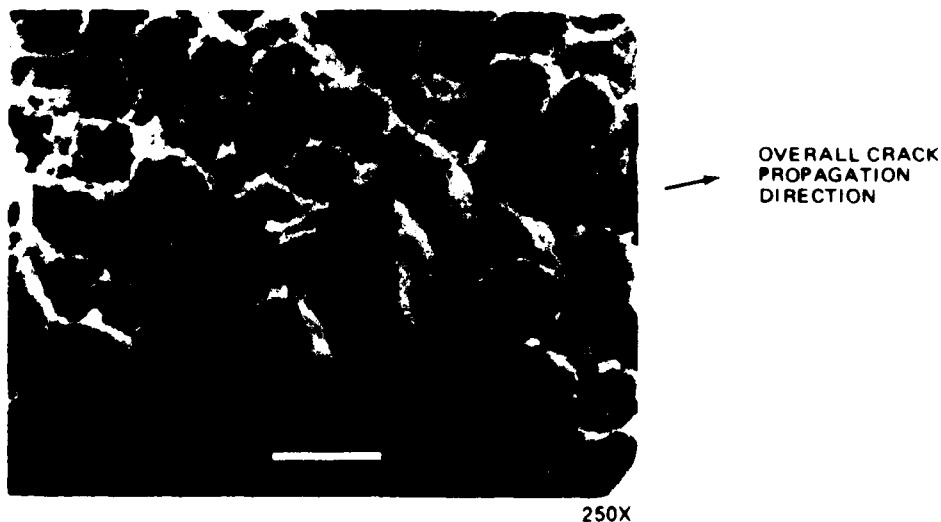
Figure 4-31. SEM Photomicrograph Showing Direction of Crack Propagation

Tension failure does not usually progress by a well defined crack front. Due to flaw sensitivity, the fracture process involves a series of zones in which all the fiber breaks within each zone originate at a single fiber. Thus, the crack front actually consists of numerous isolated fracture zones (at different planes) that coalesce and propagate in the overall growth direction. This phenomena produces the distinct fracture zones commonly referred to as fiber bundles. Fiber ends tend to fracture in a variety of directions, although they are often noticeable biased in a single overall direction. Through extensive SEM mapping of the fiber ends (Figure 4-31) the macroscopic growth direction can be determined. Extreme caution must be exercised in the evaluation of isolated fibers that protrude from the main surface. To increase accuracy, many areas of crack growth

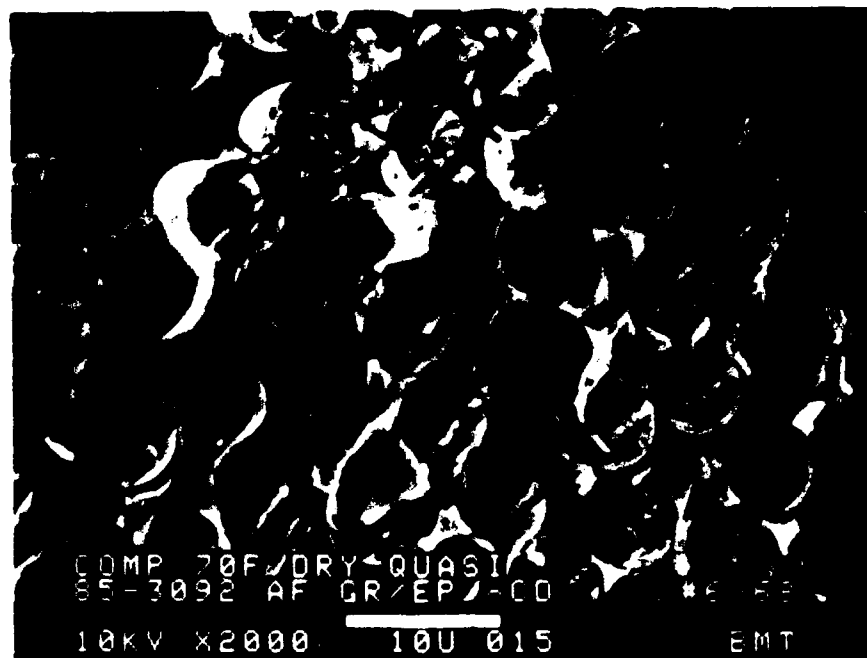
Figure 4-37. Fiber End Fracture Morphology From Compression Buckling Failure

unified direction, as presented in Figure 4-37. Preliminary controlled crack growth studies have shown that the neutral axis lines are often biased at an angle parallel to the direction of induced crack propagation. This indicates that flexural fiber collapse, and thus crack propagation on a microscopic scale, often occurs transverse to the gross overall crack direction; therefore, neutral axis lines cannot be used to determine the direction of crack propagation.

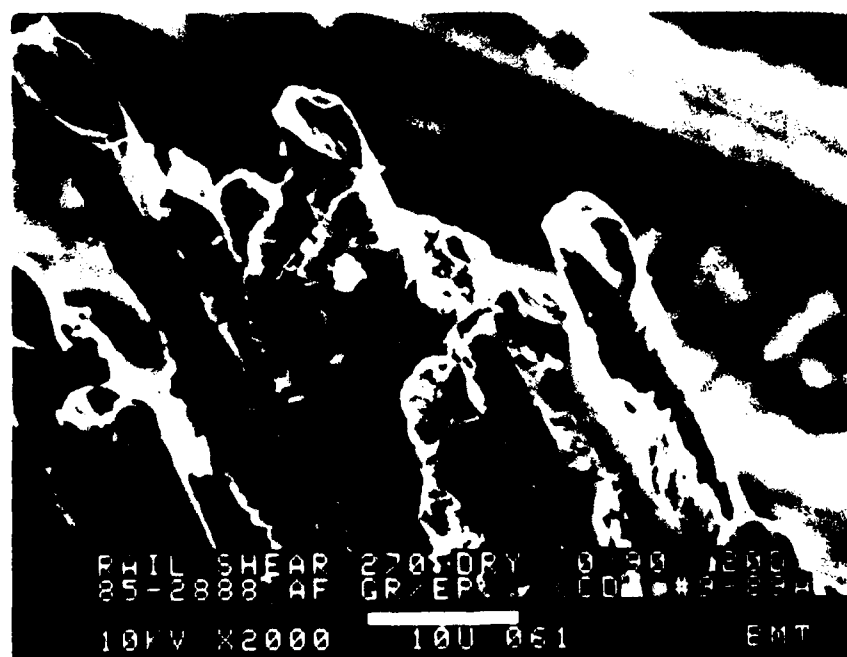
270°F. dry

← Crack direction

Figure 4-38. Slant or Shear-Type Fracture From Compression-Induced Translaminar Failure

Laminates which have superior constraint in the through-thickness direction or excellent fiber/matrix interfacial strength are not as subject to localized delaminations or microbuckling of the plies. In this case, the fibers fracture on a microscale due to shear, with individual fiber ends exhibiting a slant type fracture, as shown in Figure 4-38.

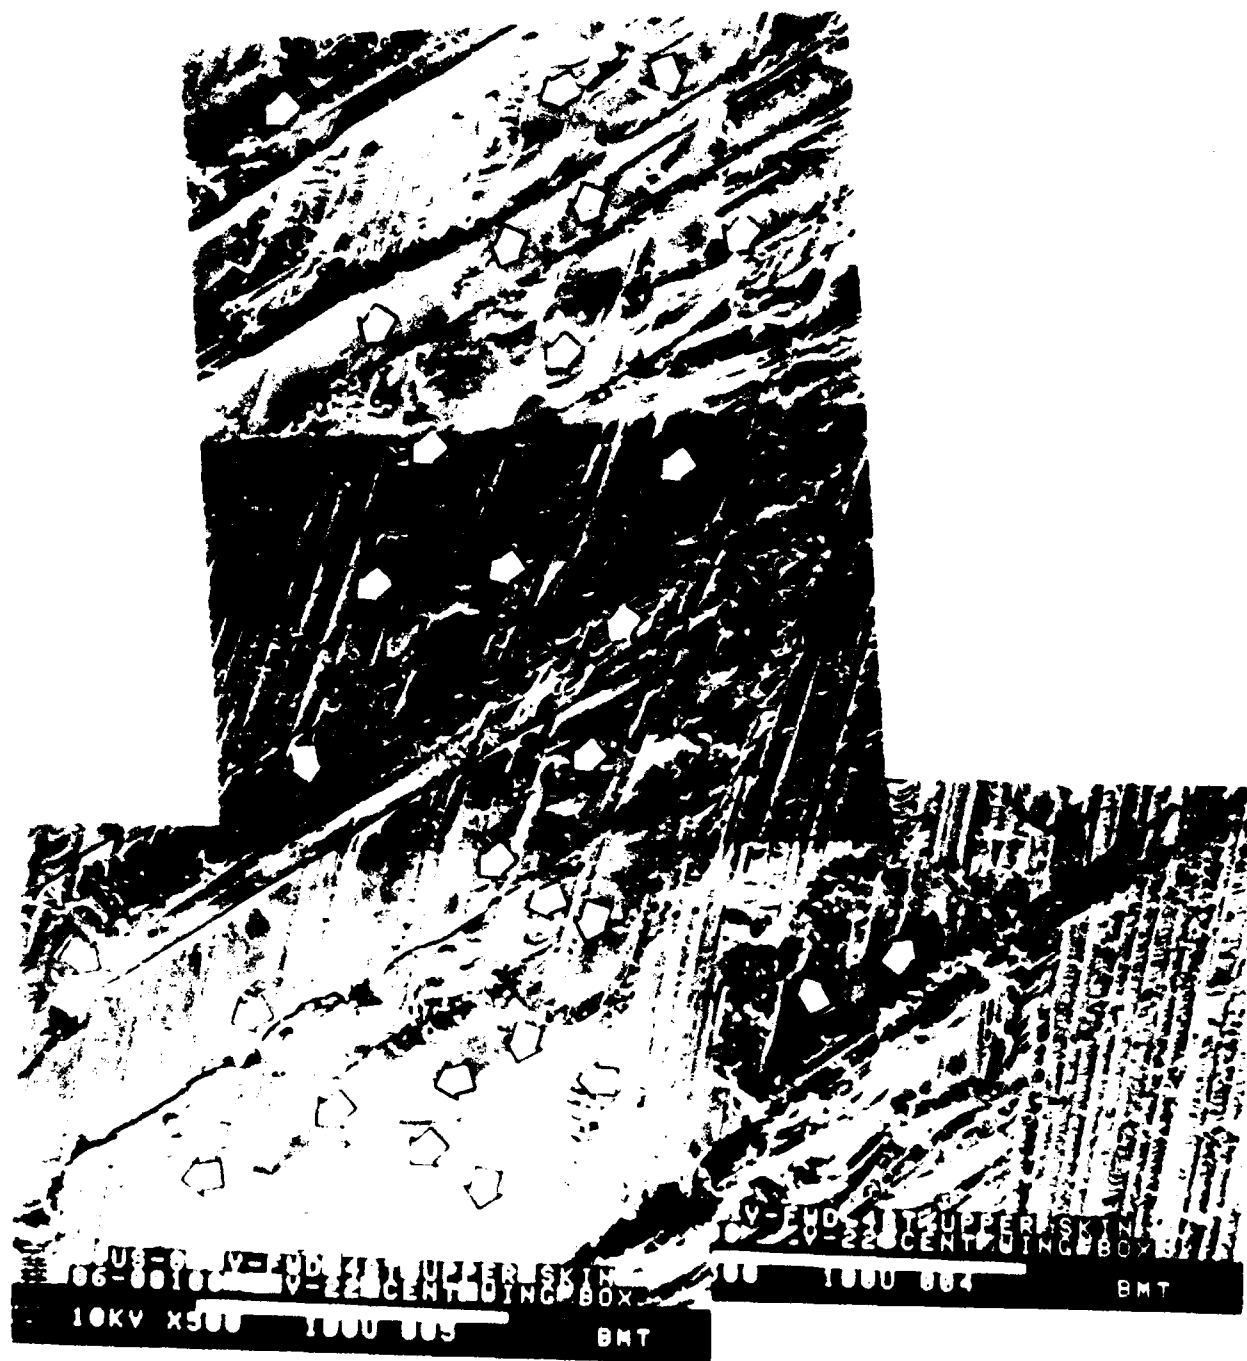
Figure 4-39. SEM Photomicrographic Montage Showing Crack Propagation Direction Mapping

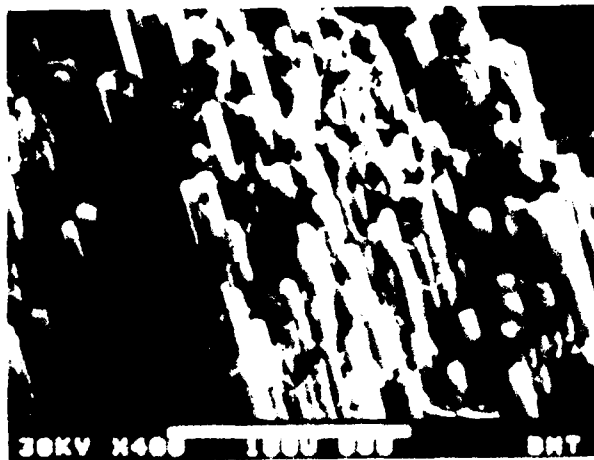
-65° test condition

70° test condition

270° F wet condition

Figure 4-41. SEM Micrographs of Translamellar Fracture Conditions at Different Temperatures

Typical translaminar fractures generated at room temperature exhibit combined features of good fiber-matrix adhesion, limited fiber pullout, and a tendency of the fibers to fail in bundles. However, translaminar fractures generated under hot/wet environmental conditions approaching the glass transition temperature exhibit greater levels of fiber pullout, combined with significantly less resin adhering to the fiber surface. Additionally, similar fractures generated under dry conditions at -65°F reveal very limited amounts of fiber pullout, with extensive amounts of residual resin on the fiber surface. In general, these observations are in agreement with published literature and illustrate the significant reduction in matrix shear strength or fiber-to-matrix interfacial strength that tends to occur under elevated-temperature and high absorbed moisture conditions. Figure 4-41 illustrates the tendency toward increased fiber/matrix separation and individual fiber pullout in wet specimens experiencing an increase in temperature.

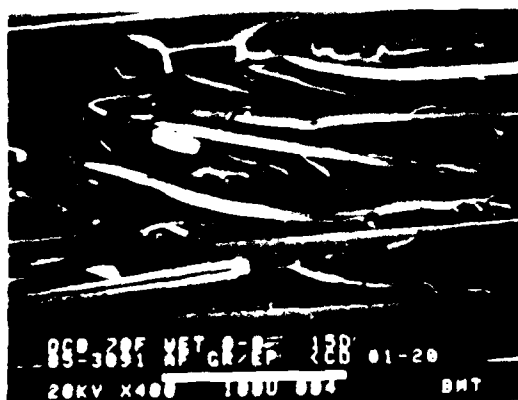
-54°C (-65°F) Dry

82°C (180°F) Wet

21°C (70°F) Wet

132°C (270°F) Dry

82°C (180°F) Dry

132°C (270°F) Wet

←
Mechanically induced crack direction

Figure 4-42 Low Magnification Series of Characteristic 0°-deg Interface Mode I Fractures at Each Environmental Condition

For delamination fractures, similar tendencies are evident for conditions of increasing amounts of absorbed moisture and temperature. Fractures in 177°C cure epoxy systems which occur at temperatures below approximately 90°C are very similar in appearance to the room temperature fractures. However, above this temperature range, increased fiber/matrix separation is evident and the fracture plane tends to occur within, or adjacent to, densely packed fiber regions within the lamina, resulting in a fiber-dominated fracture appearance, with small, localized regions of resin fracture (Figures 4-42 and 4-43).

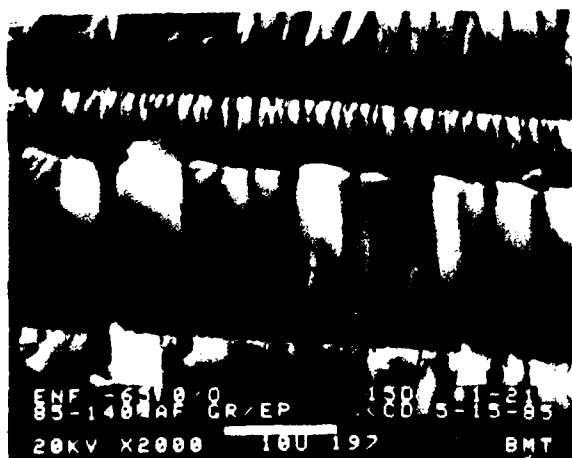
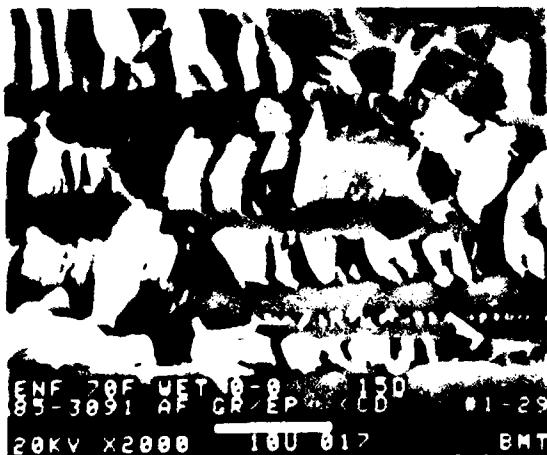
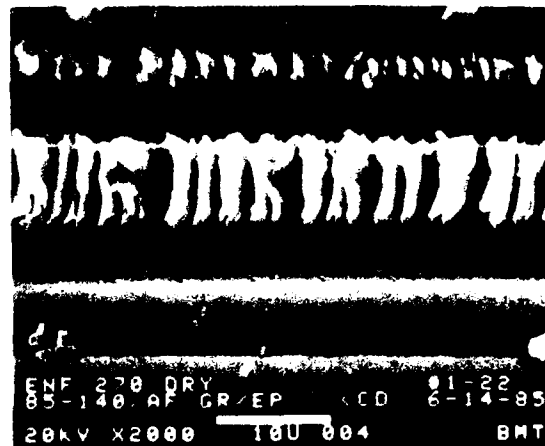
-54°C (-65°F) Dry

82°C (180°F) Wet

21°C (70°F) Wet

132°C (270°F) Dry

← Mechanically induced crack direction

Figure 4-43. High Magnification SEM Series of 0/0-deg Interface Mode II (Shear) Fractures Showing Features of Fiber-Matrix Separation

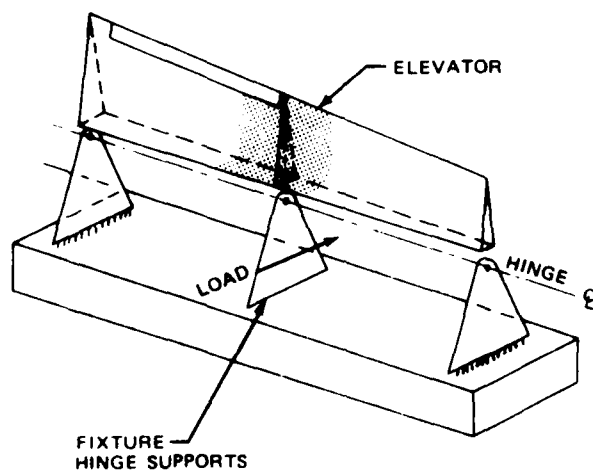
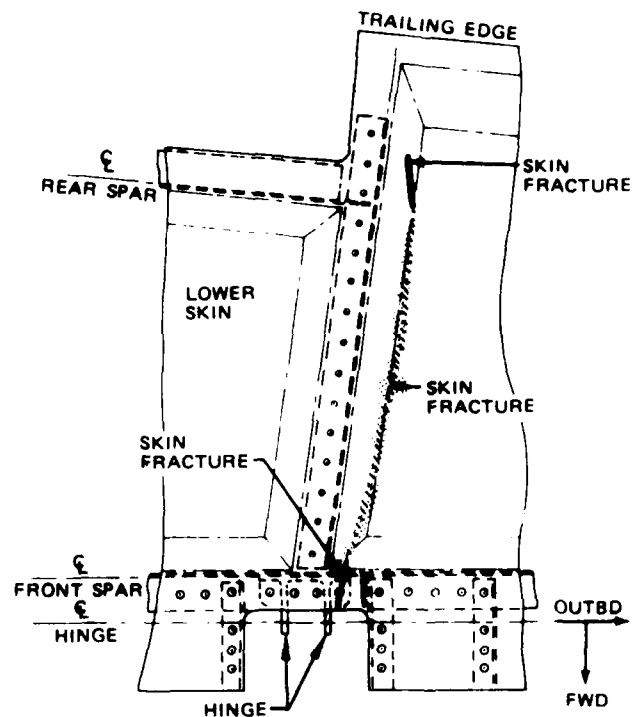
Figure 5-1. 737-300 Elevator Static Test Evaluation

NOTE Figure illustrates orientation and direction of applied loads and approximate fracture location and type.

Figure 5-1 illustrates a portion of a graphite/epoxy tapered box structure which fractured during test. This graphite/epoxy box consisted of two honeycomb skin panels fastened to a spanwise spar with intermediate chordwise ribs. A review of the test history revealed that premature fracture occurred during hingeline deflection of the front spar.

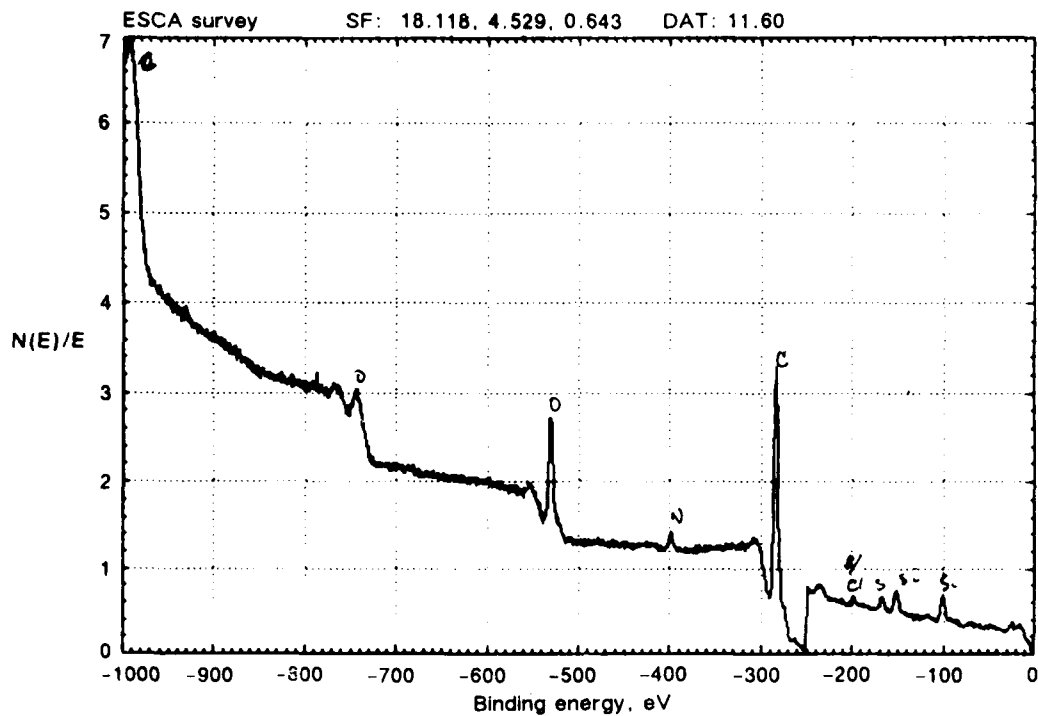
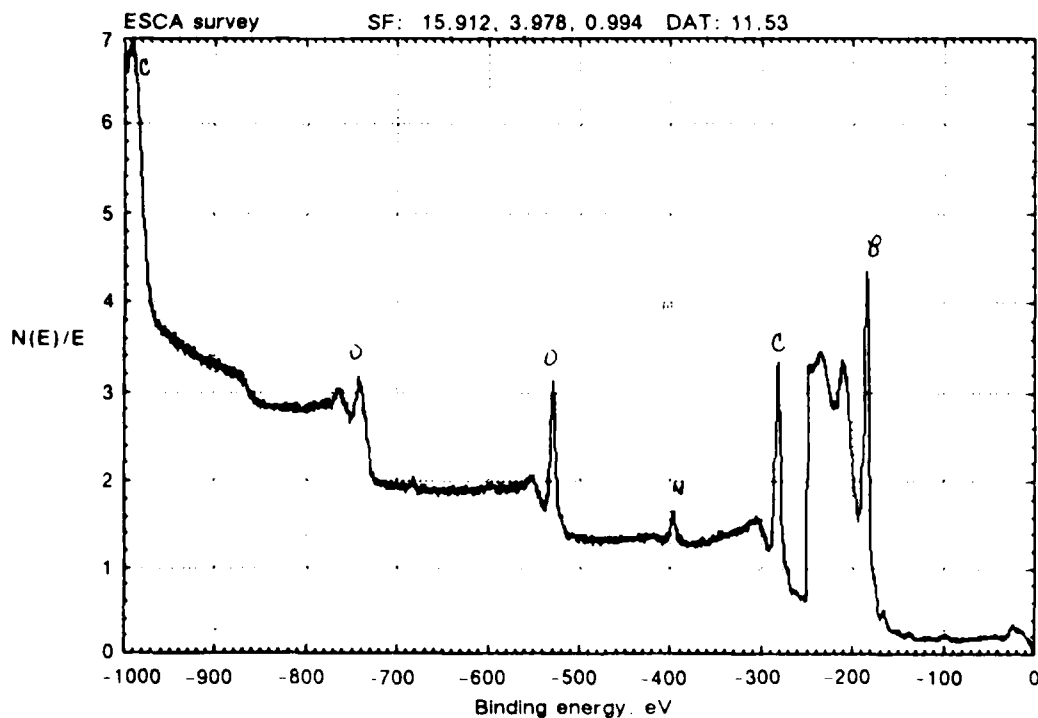
Figure 5-13. Fiber Identification by Surface Analysis

(a) Carbon Fiber Identification

(b) Boron Fiber Identification

The materials used to construct the wing were found to be carbon, boron-tungsten, and fiberglass fibers in an epoxy resin. These material constituents were identified by the following techniques; scanning electron microscopy, optical microscopy, electron probe microanalysis, and electron scattering for chemical analysis (ESCA). The fibers were identified by SEM, ESCA (Figure 5-13), and optical microscopy (Figure 5-14). The novalac based epoxy resin was identified by infrared spectroscopy.

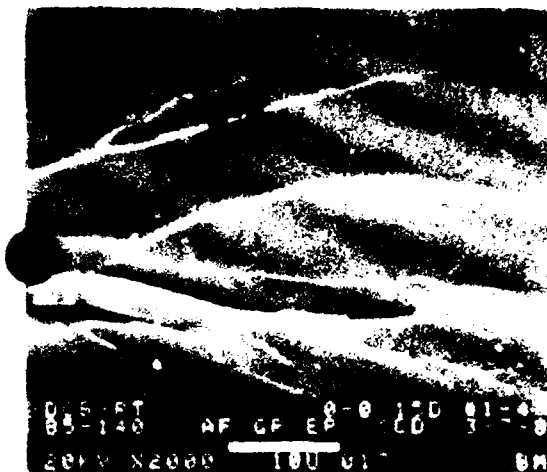
Figure 6-6. Fiber Matrix Separation, Fracture, and River Markings

Fracture type	Interlaminar mode I tension
Ply layup	[0]24
Test type	DCB
• Test conditions	21°C dry
• Fracture between	0/0 plies
Material	Hercules 3501-6/177° C cure AS4 fibers

←
Mechanically induced
crack direction

- F Fiber matrix separation
- M Matrix fracture
- R River markings

Crack growth directions can be determined by examining the flat regions between fibers. The direction of river mark branching and the radiating nature of the resin microflow are oriented in the direction of crack growth (see Figure 6-3).

River marks are concentrated adjacent to the fibers where cracking tends to continually reiterate on a microscale. In other cases, where overall cracking progresses in a direction other than parallel to the fibers, these river marks are concentrated on the side of the fiber away from the origin (see Figure 6-4).

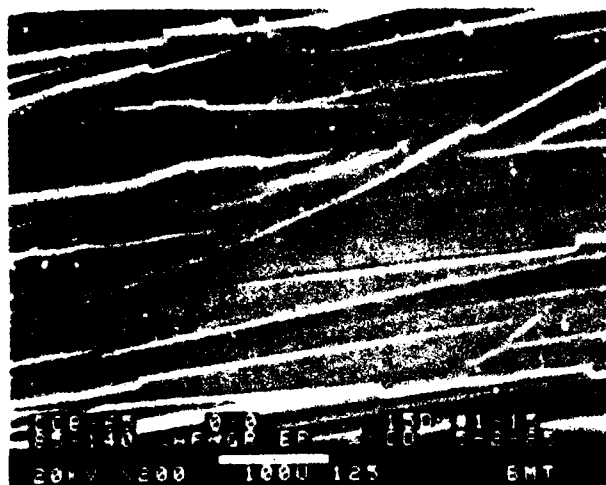
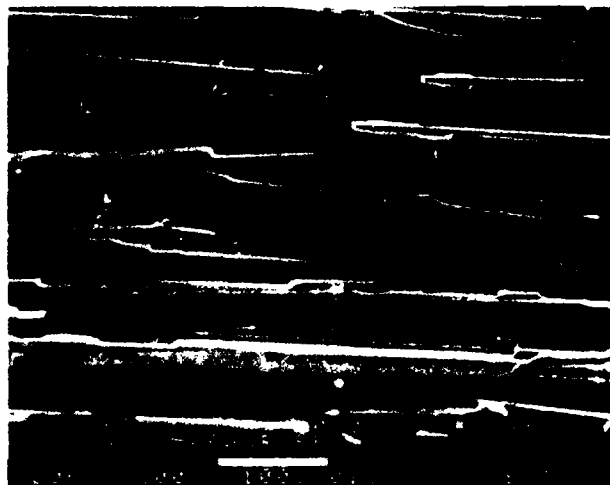
Figure 6-9. -65°F Dry, 70°F Dry, and 270°F Dry Conditions (SEM 200X)

Fracture type	Interlaminar mode I tension
Ply layup	[0] 24
Test type	DCB
• Test conditions	Dry
• Fracture between	0/0 plies
Material	Hercules 3501-6/177° C cure AS4 fibers

← Mechanically induced crack direction

-65° F. dry

70° F. dry

270° F. dry

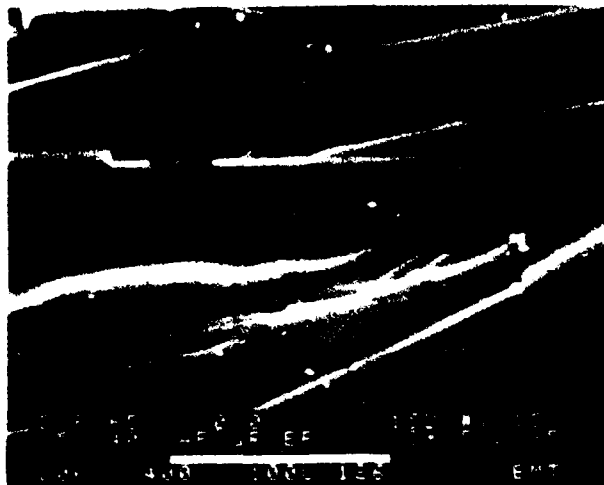
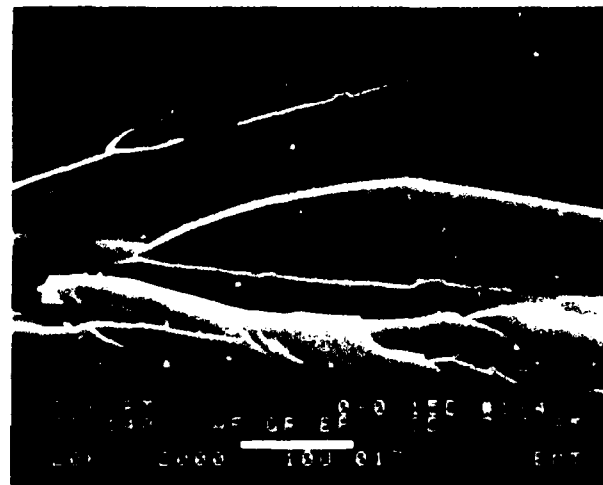
Figure 6-10. -65°F and 70°F Dry Conditions (SEM)

Fracture type	Interlaminar mode I tension
Ply layup	[0] ₂₄
Test type	DCB
• Test conditions	Dry
• Fracture between	0/0 plies
Material	Hercules 3501-6/177°C cure AS4 fibers

F Fiber matrix separation
R River markings
M Matrix fracture

← Mechanically induced crack direction

-65°F, dry

70°F, dry

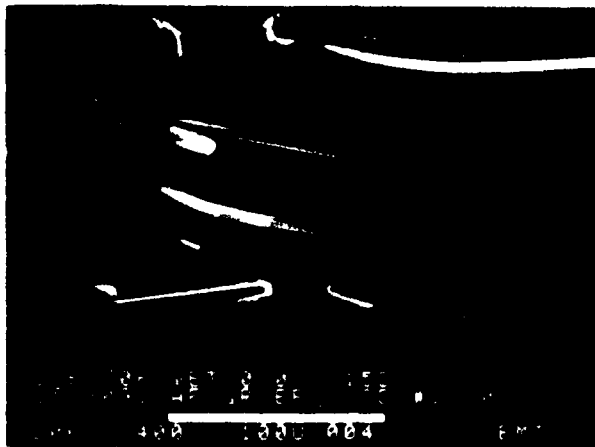
Figure 6-11. 70°F Wet and 180°F Wet Conditions

Fracture type	Interlaminar mode I tension
Ply layup	[0] 24
Test type	DCB
• Test conditions	Wet
• Fracture between	0/0 plies
Material	Hercules 3501-6/177°C cure AS4 fibers

←
Mechanically induced crack direction

70°F, wet

180°F, wet

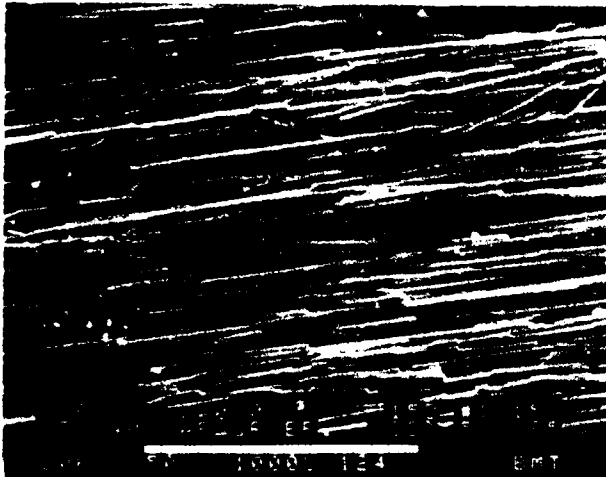
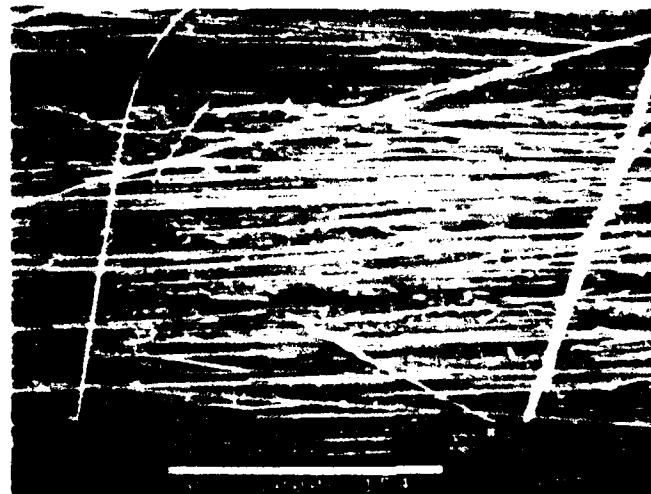
Figure 6-12. -65°F Dry, 70°F Dry, and 270°F Dry Conditions (SEM 50X)

Fracture type	Interlaminar mode I tension
Ply layup	[0] 24
Test type	DCB
• Test conditions	Dry
• Fracture between	0/0 plies
Material	Hercules 3501-6/177° C cure AS4 fibers

←
Mechanically Induced crack direction

-65°F. dry

70°F. dry

270°F. dry

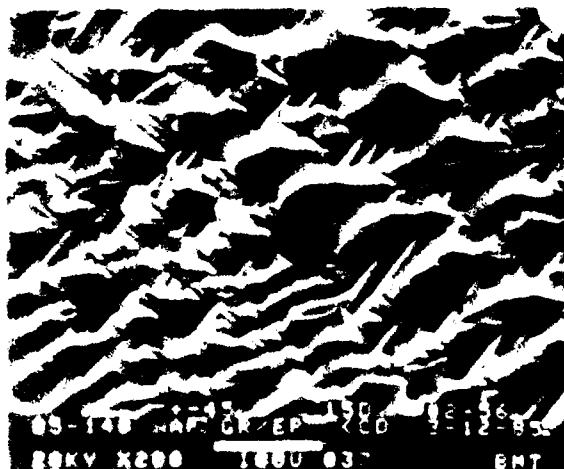
Figure 6-15. +45/-45 Plies With Matrix Fracture, Fiber Separation, River Marks, and Textured Microflow

Fracture type	Interlaminar mode I tension
Ply layup	[+45, -45] 12S
Test type	DCB
• Test conditions	21°C dry
• Fracture between	+45/-45 plies
Material	Hercules 3501-6/177°C cure AS4 fibers

- F Fiber matrix separation
- M Matrix fracture
- R River markings
- T Textured microflow

Mechanically induced crack direction

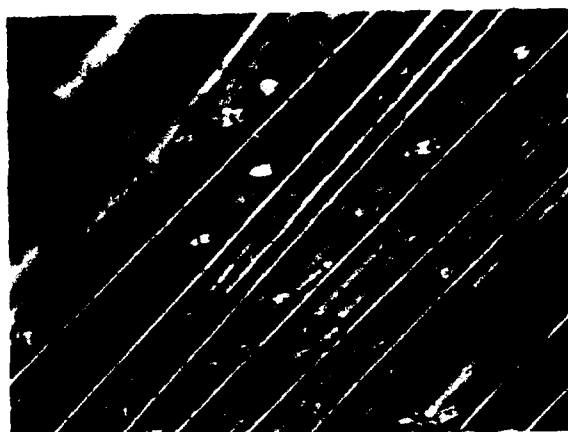
Figure 6-17. +45/-45 Plies at 70°F Wet Conditions (Optical 400X)

Fracture type	Interlaminar mode I tension
Ply layup	[+45, -45] ₁₂ S
Test type	DCB
• Test conditions	Wet
• Fracture between	+45/-45 plies
Material	Hercules 3501-6/177°C cure AS4 fibers

70°F. wet

180°F. wet

← Mechanically induced crack direction

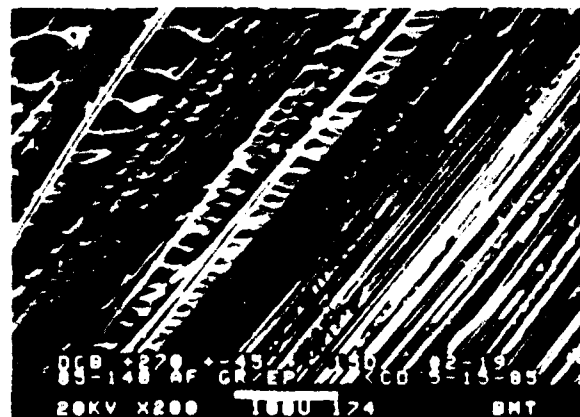
Figure 6-19. +45/-45 Plies at -65°F Dry, 70°F Dry, and 270°F Dry Conditions (SEM 200X)

Fracture type	Interlaminar mode I tension
Ply layup	[+45,-45] 12S
Test type	DCB
• Test conditions	Dry
• Fracture between	+45/-45 plies
Material	Hercules 3501-6/177°C cure AS4 fibers

←
Mechanically induced crack direction

-65°F. Dry

70°F. Dry

270°F. Dry

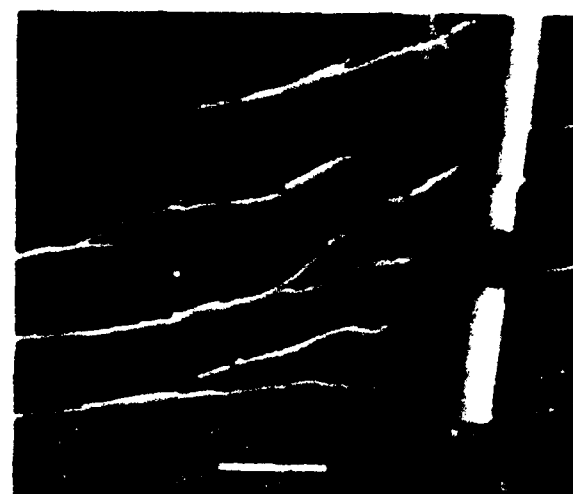
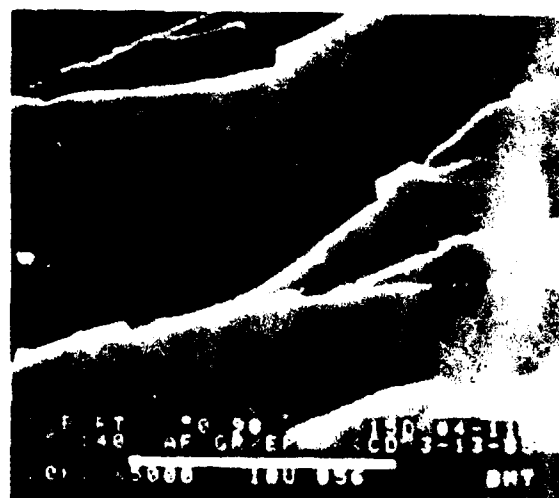
Figure 6-25. 0/90 Plies With Matrix Fracture, Fiber Separation, River Marks, and Textured Microflow

Fracture type	Interlaminar mode I tension
Ply layup	[0, 90] _{12S}
Test type	DCB
• Test conditions	21°C, dry
• Fiber end fracture	
Material	Hercules 3501-6/177°C cure AS4 fibers

- F Fiber matrix separation
- M Matrix fracture
- R River markings
- T Textured microflow

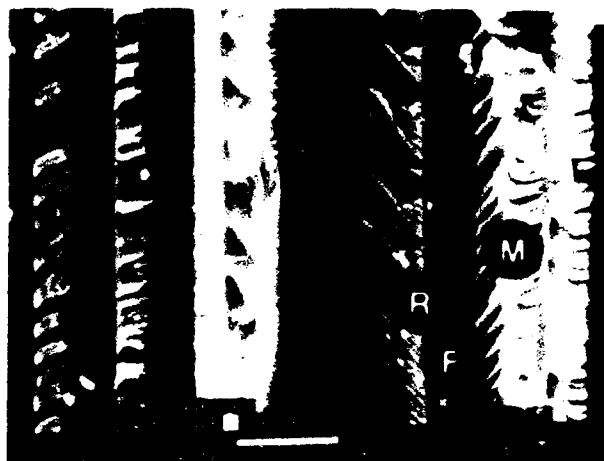
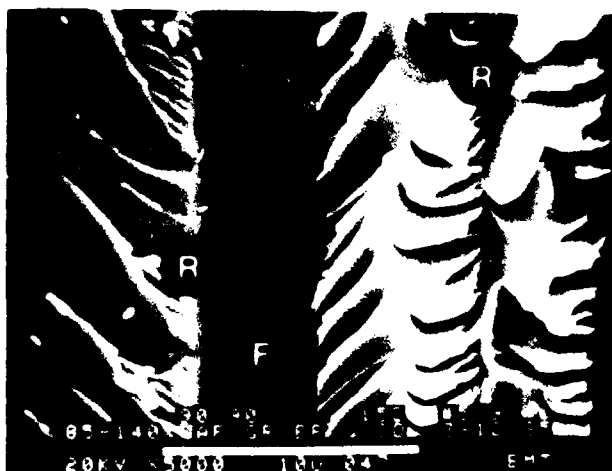
Figure 6-28. 0/90 Plies at 21°C Dry Condition With Matrix Fracture, Fiber Separation, and River Marks

Fracture type	Interlaminar mode I tension
Ply layup	[90] ₂₄
Test type	DCB
• Test conditions	21°C. dry
• Fracture between	0/90 plies
Material	Hercules 3501-6/177°C cure AS4 fibers

- F Fiber matrix separation
- M Matrix fracture
- R River markings

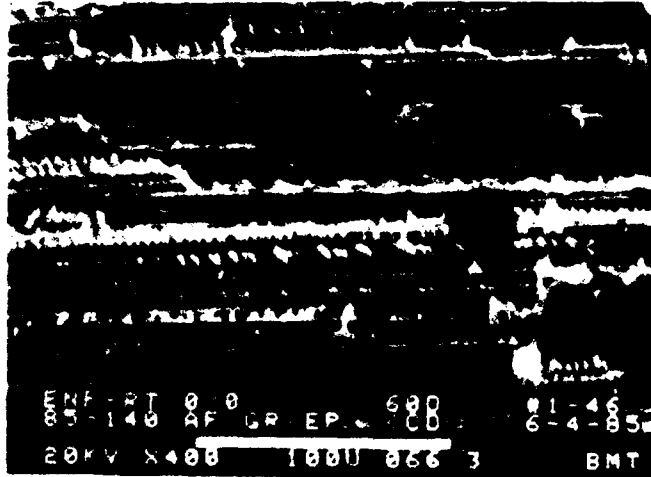
Figure 6-31. 0/0 Plies at 21°C Dry Condition With Fiber Separation, River Marks, Hackles, and Textured Microflow

Fracture type	Interlaminar mode II shear
Ply layup	[0] 24
Test type	ENF
• Test conditions	21°C. dry
• Fracture between	0/0 plies
Material	Hercules 3501-6/177° C cure AS4 fibers

- F Fiber matrix separation
- H Hackles
- R River markings
- T Textured microflow

See Figures 6-30 through 6-46.

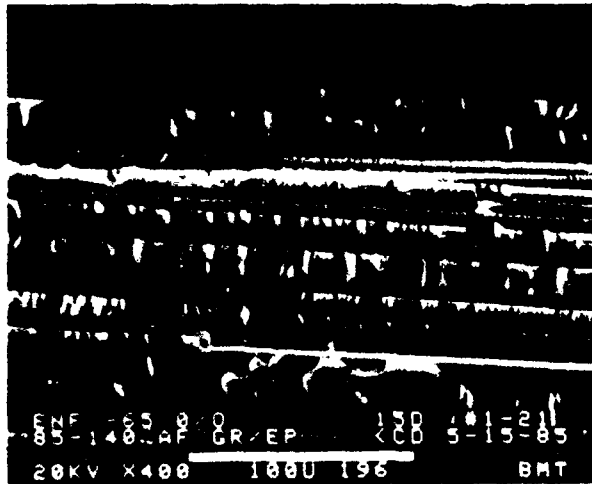
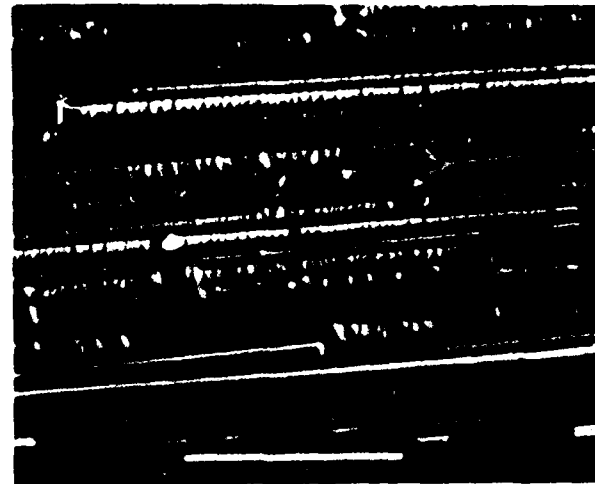
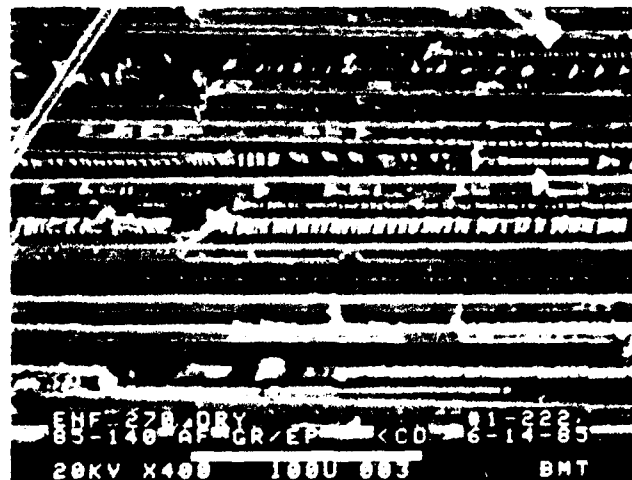
Figure 6-34. 0/0 Plies at -65°F Dry, 70°F Dry, and 270°F Dry Conditions (SEM 400X)

Fracture type	Interlaminar mode II shear
Ply layup	[0] ₂₄
Test type	ENF
• Test conditions	Dry
• Fracture between	0/0 plies
Material	Hercules 3501-6/177° C cure AS4 fibers

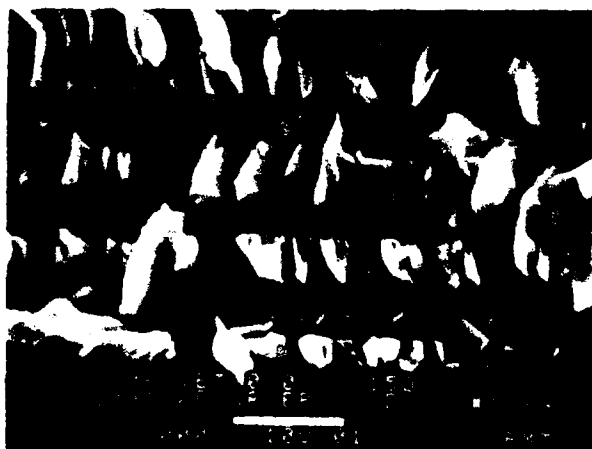
Figure 6-35. 0/0 Plies at 70°F Wet and 180°F Wet Conditions With Fiber Separation and Hackles

Fracture type	Interlaminar mode II shear
Ply layup	[0] 24
Test type	ENF
• Test conditions	Wet
• Fracture between	0/0 plies
Material	Hercules 3501-6/177° C cure AS4 fibers

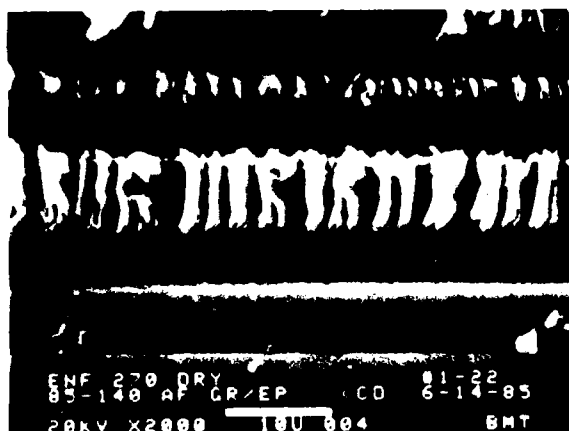
Figure 6-36. 0/0 Plies at -65°F Dry, 70°F Dry, and 270°F Dry Conditions With Fiber Separation and Hackles

Fracture type	Interlaminar mode II shear
Ply layup	[0] 24
Test type	ENF
• Test conditions	Dry
• Fracture between	0/0 plies
Material	Hercules 3501-6/177°C cure AS4 fibers

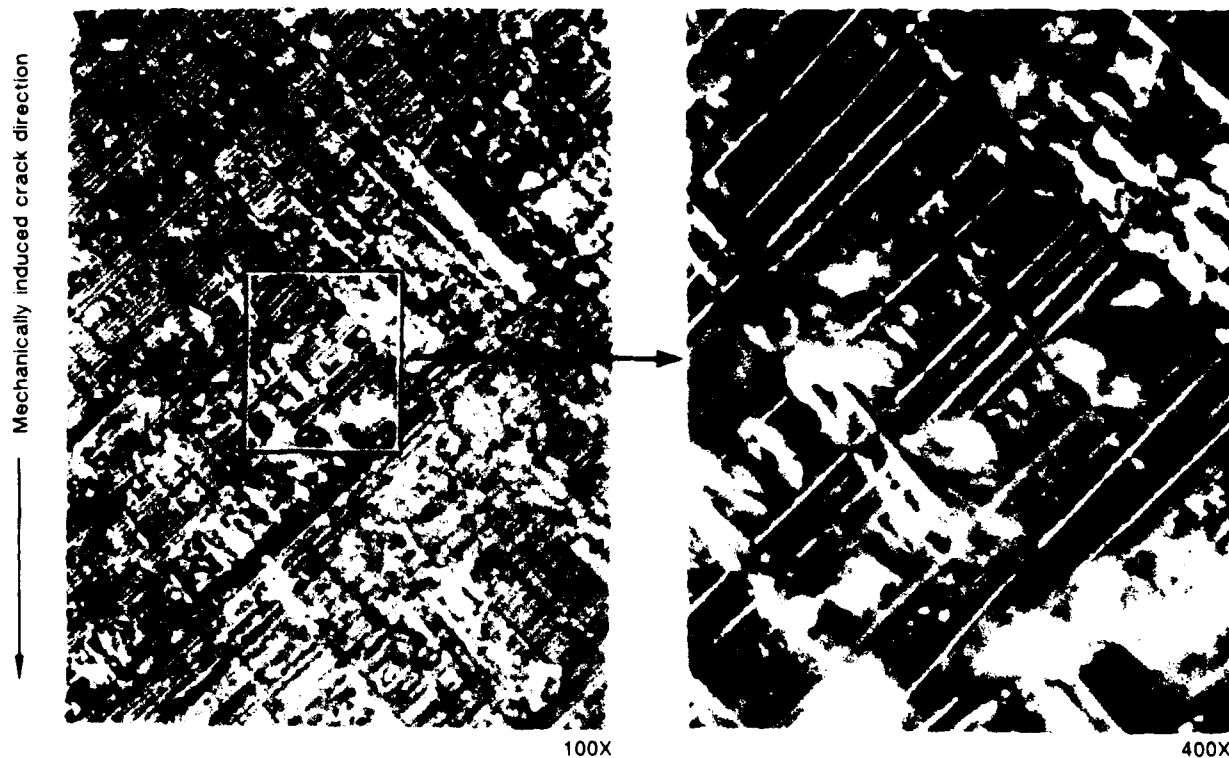
Figure 6-37. +45/-45 Plies at 21°C Dry Condition (Optical 100X and 400X)

Fracture type	Interlaminar mode II shear
Ply layup	[+45/-45] _{12S}
Test type	ENF
• Test conditions	21°C, dry
• Fracture between	+45/-45 plies
Material	Hercules 3501-6/177°C cure AS4 fibers

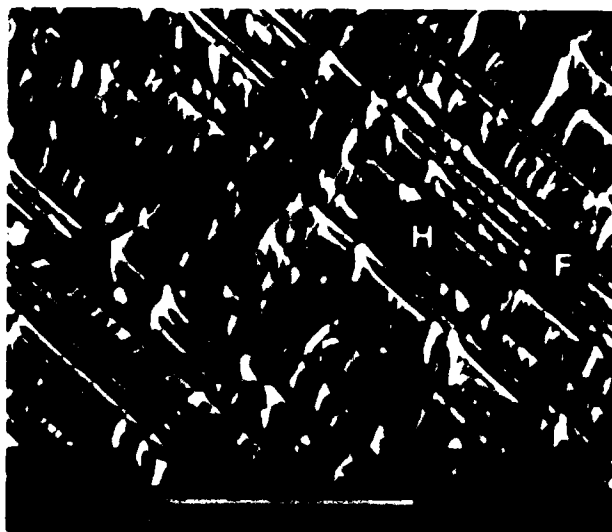
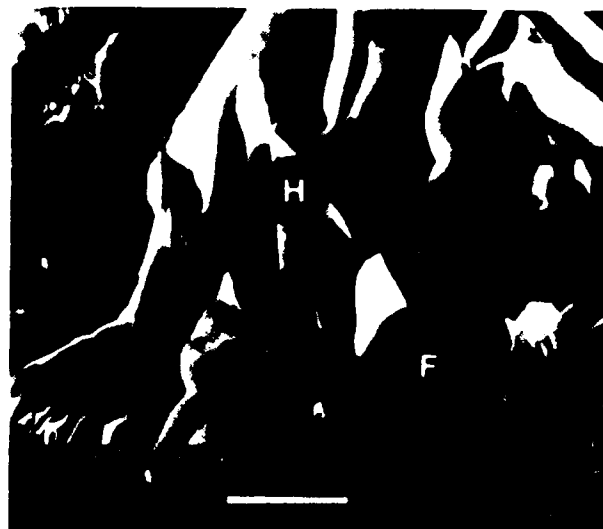
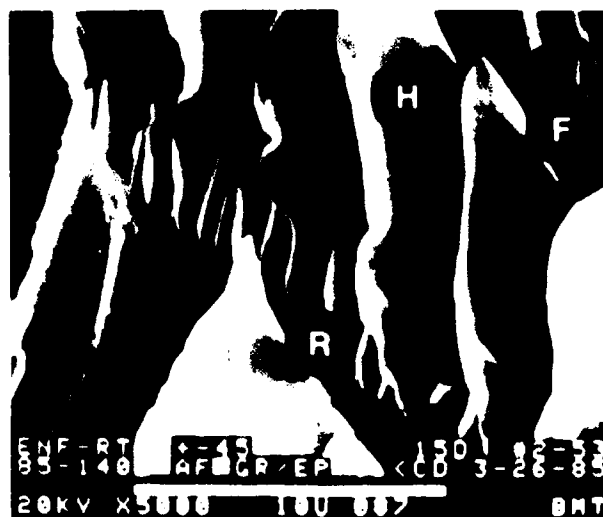
Fracture type	Interlaminar mode II shear
Ply layup	[+45/-45] 12S
Test type	ENF
• Test conditions	21°C, dry
• Fracture between	+45/-45 plies
Material	Hercules 3501-6/177°C cure AS4 fibers

- F Fiber matrix separation
- H Hackles
- R River markings

Figure 6-38 +45/-45 Plies at 21°C Dry Condition With Fiber Separation, River Marks, and Hackles

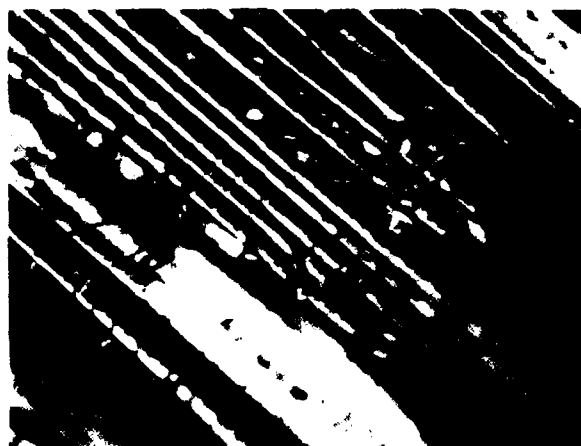
Fracture type	Interlaminar mode II shear
Ply layup	[+45/-45] 12S
Test type	ENF
• Test conditions	Dry
• Fracture between	+45/-45 plies
Material	Hercules 3501-6/177°C cure AS4 fibers

Figure 6-39. +45/-45 Plies at -65°F Dry, 70°F Dry, and 270°F Dry Conditions (Optical 400X)

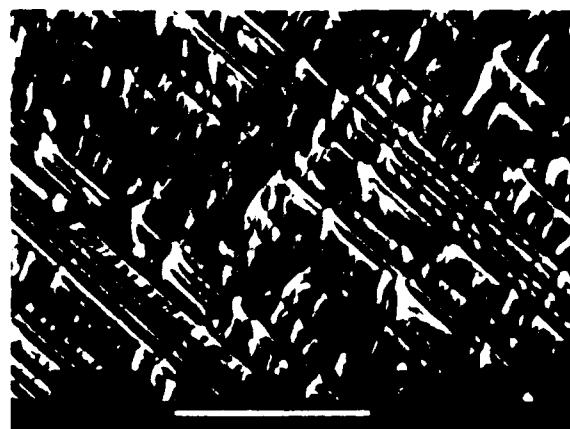
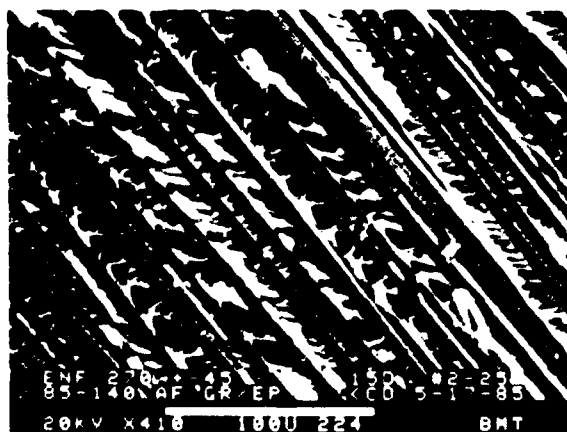
Fracture type	Interlaminar mode II shear
Ply layup	[+45, -45] _{12S}
Test type	ENF
• Test conditions	Dry
• Fracture between	+45/-45 plies
Material	Hercules 3501-6/177°C cure AS4 fibers

Figure 6-40. +45/-45 Plies at -65°F Dry, 70°F Dry, and 270°F Dry Conditions (SEM 400X)

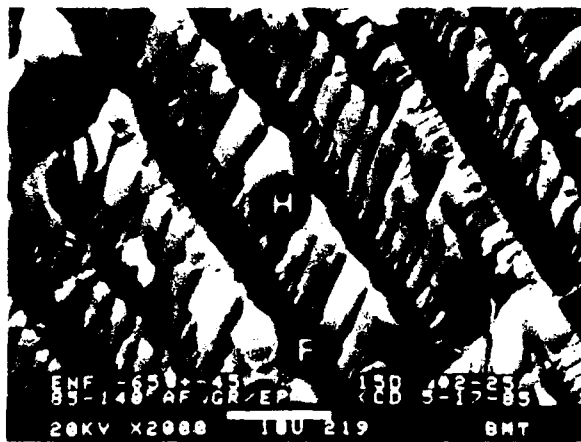
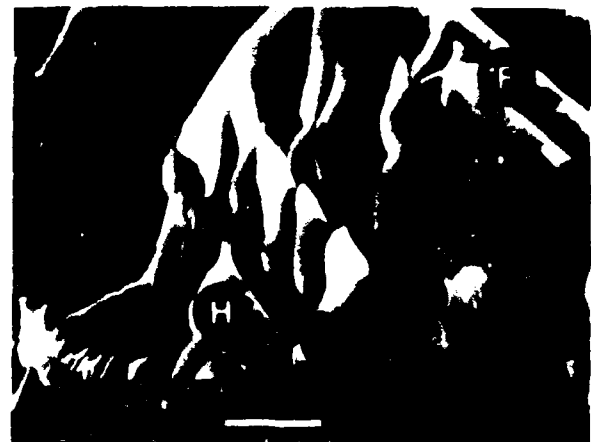
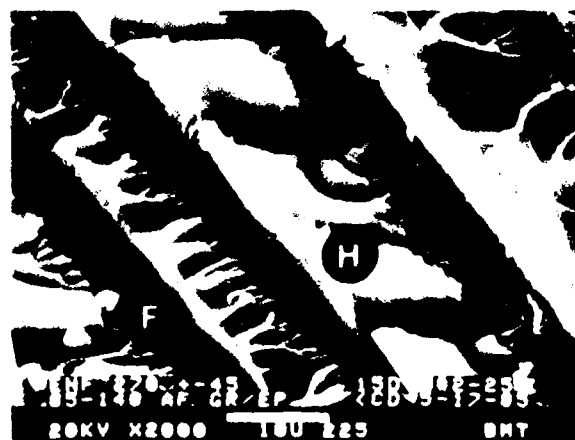
Fracture type	Interlaminar mode II shear
Ply layup	[+45/-45] 12S
Test type	ENF
• Test conditions	Dry
• Fracture between	+45/-45 plies
Material	Hercules 3501-6/177°C cure AS4 fibers

F Fiber matrix separation
H Hackles

Figure 6-41. +45/-45 Plies at -65°F Dry, 70°F Dry, and 270°F Dry Conditions (SEM 2000X)
